## CATHOLIC APOSTOLIC CHURCH - Albury – Stone repairs to listed church.

Client – Trustees of Catholic Apostolic Church

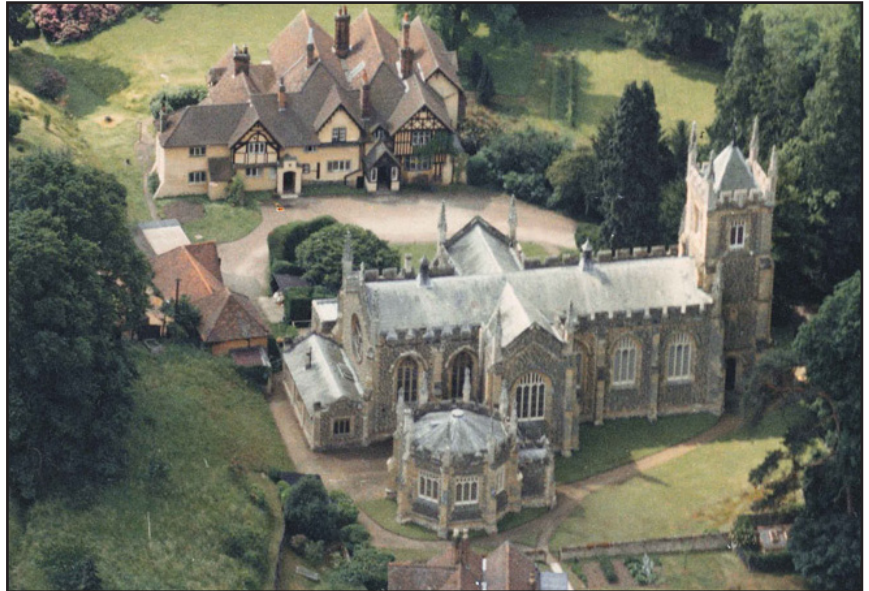
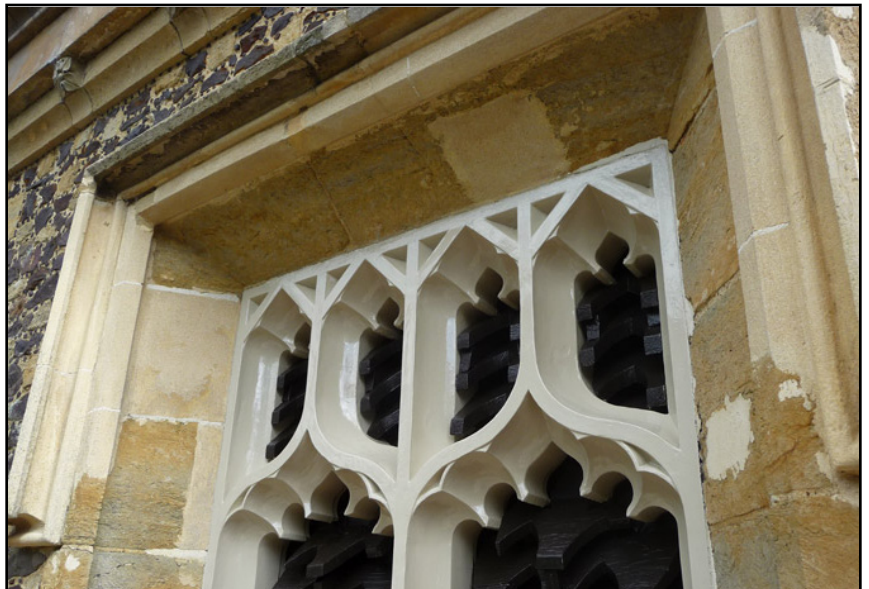
The church stonework is mainly of local sandstone which does not have the best weather resistance and the faces of which readily spall away and which has been exacerbated by previous poor re-pointing work carried out in a cement mortar and also by poor previous plastic stone repairs. These plastic stone repairs were carried out in two phases, firstly during the 1960s and these repairs have been more effective than the later carried out in the 1980s. Our specification included for the cutting out of plastic stonework and removal of stones where significantly decayed, to be replaced with new stone, lime mortar bedded. We also included for widespread re-pointing work in a lime mortar and introduction of lead weathering courses over stone decorative string courses etc. It is intended that this will be a rolling programme working around the church and which will gradually bring the church up to a consistent maintenance standard and which can then be readily maintained in future years

A quinquennial inspection was carried out in 2001 and as a result of that inspection the trustees have accepted our recommendation to instigate a programme of carrying out roof and stonework repairs and re-pointing.
